Architectural Impact Assessment for 'The Grove' at 27 Blackburrow Road, and adjoining newer properties in Mills Circle, Hayfields, Pietermaritzburg

June 2010

Prepared for: Terratest

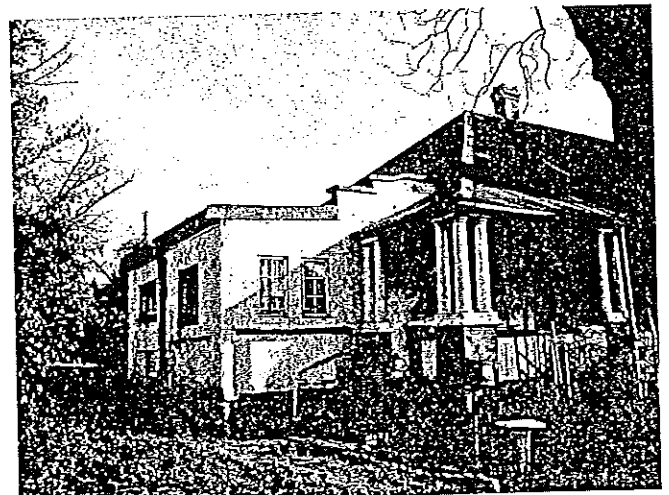
*Fig 13: enclosed raised porch,*

The eastern elevation is dominated by the projecting raised porch, which was enclosed by Mr. Mills creating a bathroom for his mother when she was elderly. Particularly notable is the pair of ungainly bay windows that project out from the elevation, hosting steel windows. It is suspected that these two are a later addition.

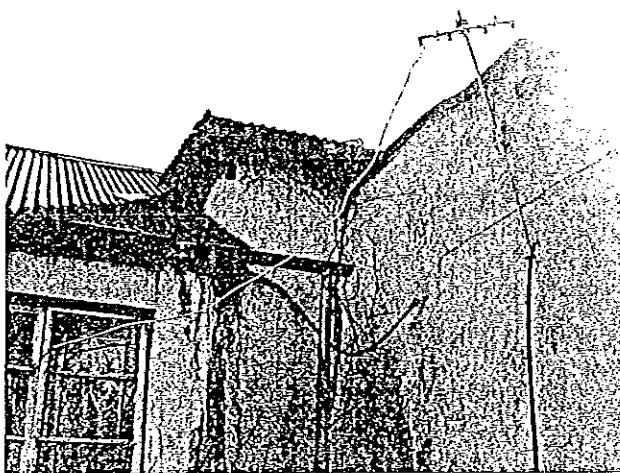
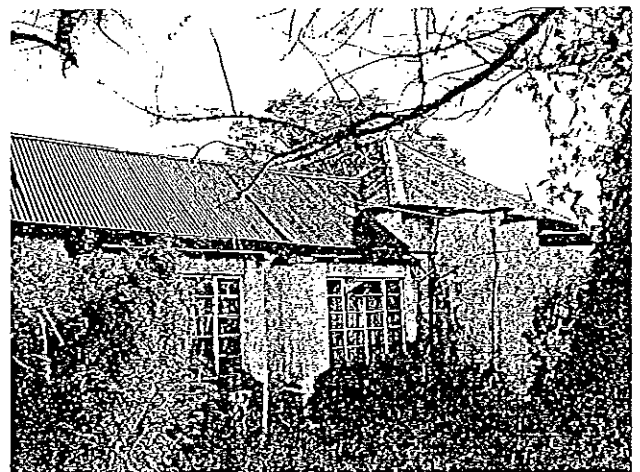
*Figs 19 & 20: Junction of old building, elevated porch and 1890's additions*

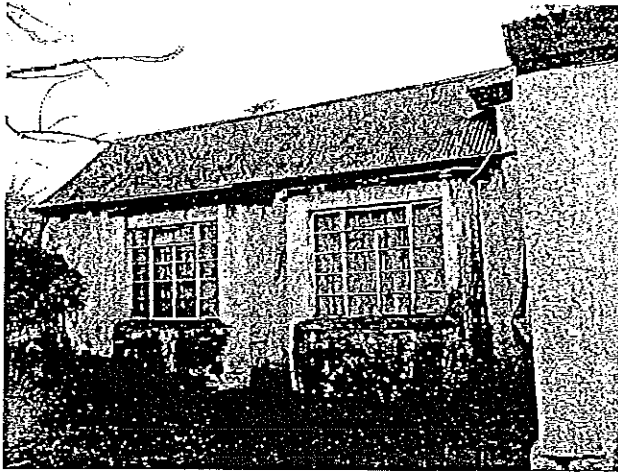
*Fig 21: bay window additions*

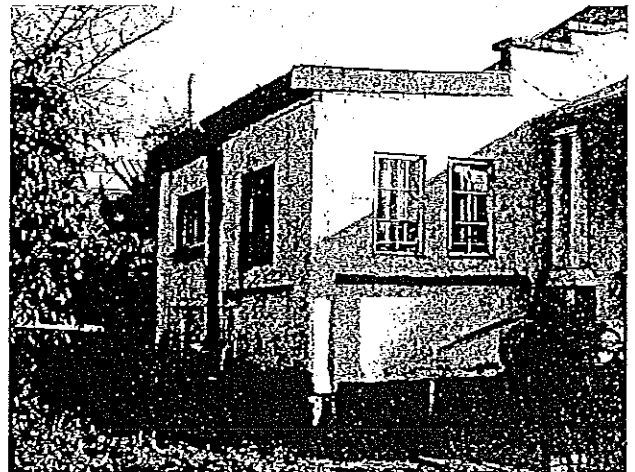
*Fig 22: raised porch now bathrooms*

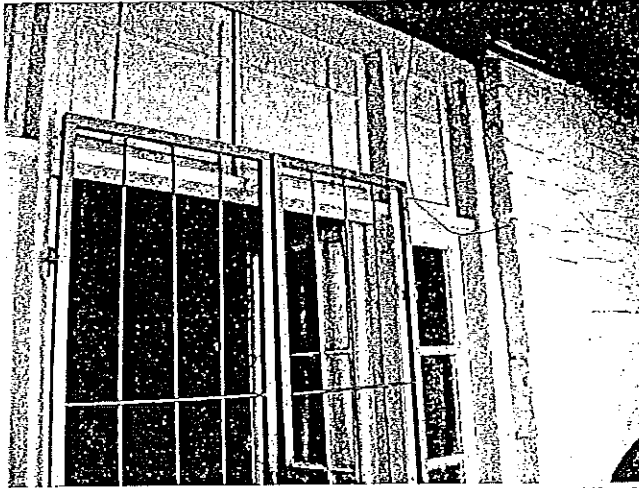
*Fig 37: window into lounge- old building*

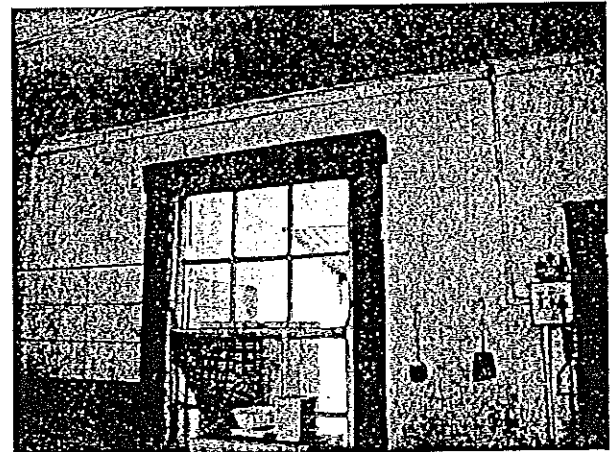
*Fig 40: window to enclosed veranda from kitchen*

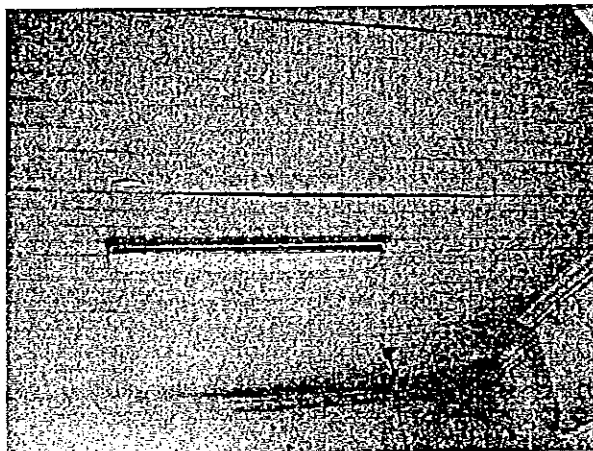
Because the house is let to a number of tenants, many of the rooms were inaccessible as they were locked. What is visible is reasonably nondescript. There is no evidence of major damage- Mr. Mills notes that the timber strip flooring in one of the rooms was totally replaced with a concrete floor when he was a boy, much of the flooring is reasonable, and the ceilings are in large part what one would expect with an old roof and a lack of maintenance.

*Fig 41: ceilings in lounge in old building*

Repairing the house would be costly. In addition to underpinning of the veranda, and propping up of the occasional collapsing arch, the roof has not had any maintenance for many years, and the timberwork on the verandas is evidence of this. Some gutters are held on by rope, and generally all repair has been reactive rather than proactive. Many of the chimneys are in need of rebuilding. Shale work on the front elevation is bursting at ground level.

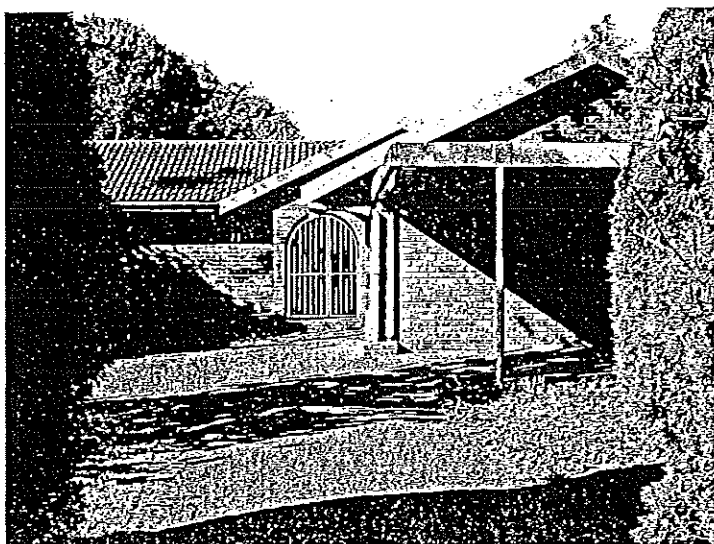
Sub 4 was alienated from Sub 1 in 1983 and sold to Johannes Gerbrand Steyn. The house is of clinker bricks and Holley Harveytile with arched entrances. Given its construction after 1983, it is not older than 60 years, and is an example of suburban architecture of which there are scores of similar examples.

*Fig 50: house on Sub 4 of 1135*

Demolition of this structure would not require a permit from Amafa as the building is not over 60 years old. Nevertheless, there is little architectural, historical or social significance in retaining the building.

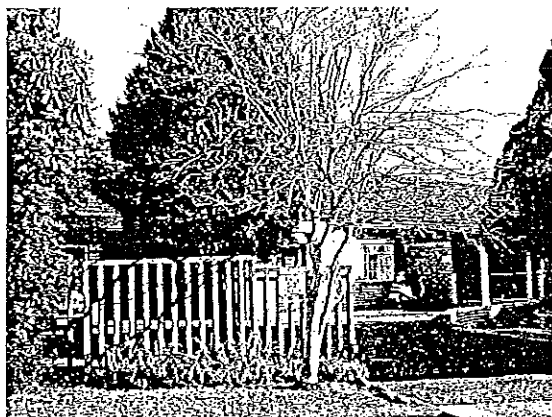
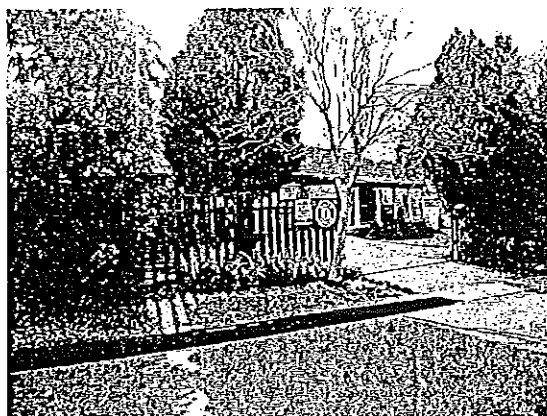
Lot 1 of 1113 was sold to Arthur Hood in 1954, although it is evident that this structure does not date from this time. It is a low, horizontal house of contemporary construction, built out of pale clay bricks and roofed with Holley Harveytile. The windows are of steel. It has candy twist Spanish columns to the added verandas.

Fig 51: front of Lot 1 of 1113

Fig 52: Lot 1 from Mills Circle

Fig 53: Lot 1 to the right and the roof of 'The Grove' to the left.

This building is not older than 60 years, and is an example of desultory suburban architecture of which there are scores of similar examples.

Demolition of this structure would not require a permit from Amafa as the building is not over 60 years old. Nevertheless, there is little architectural, historical or social significance in retaining the building.

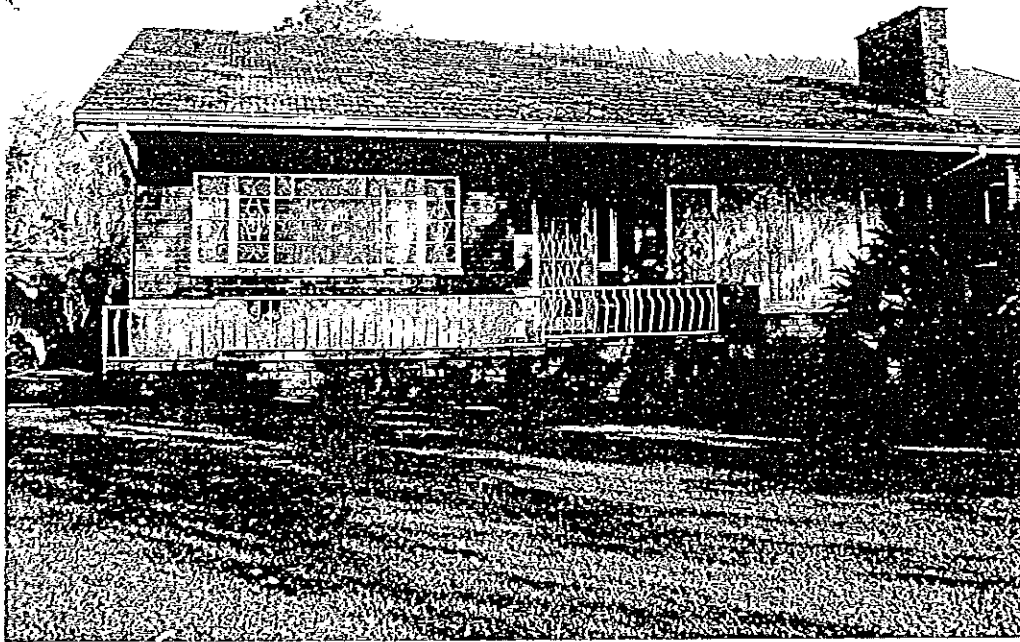
Sub 2 of Lot 1113 was sold to Arthur Hood in 1954. The building is roughly orthogonal and of common facebrick construction with raised string courses under a Marseille tile roof and with steel windows. It has a ranch type chimney. Although the property was sold to Hood in the 1950's, this building is more contemporary. It is not older than 60 years, and is an example of desultory suburban architecture of which there are scores of similar examples.

*Fig 54: House on Lot 2 of 1113*

Demolition of this structure would not require a permit from Amafa as the building is not over 60 years old. Nevertheless, there is little architectural, historical or social significance in retaining the building.

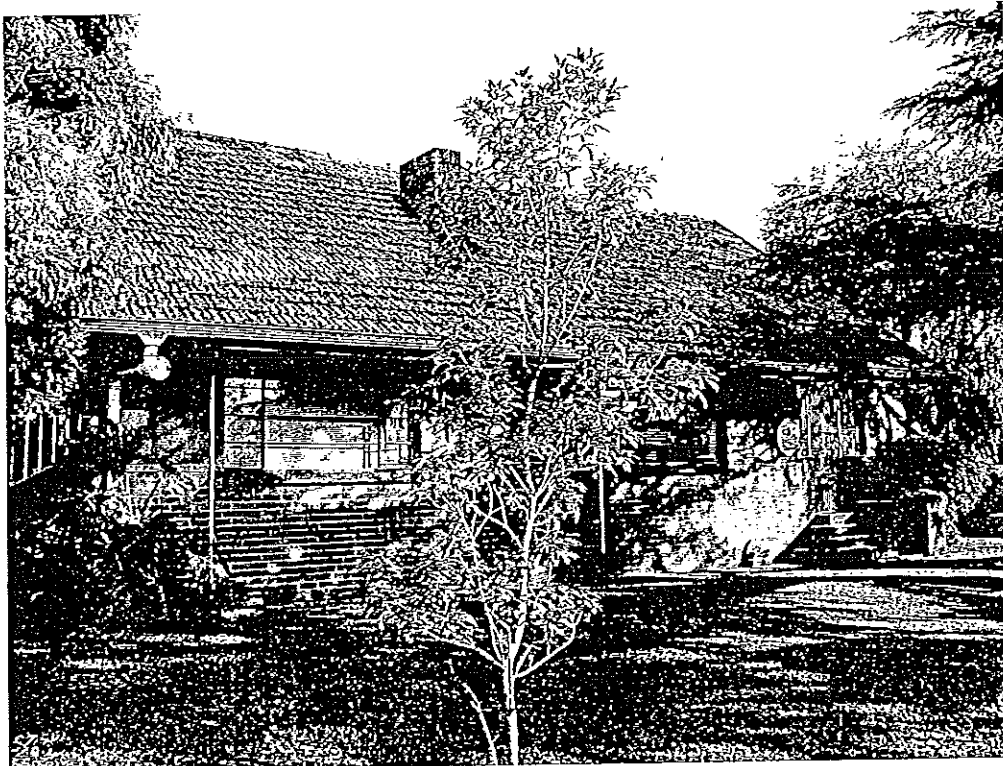
*Fig 55: House on Lot 3 of 1113*

The house is a simple building of standard masonry construction plastered and painted with steel windows under a Marseille tile roof. It has a prominent facebrick dado. It is not older than 60 years, and is an example of suburban architecture of which there are scores of similar examples.

Demolition of this structure would not require a permit from Amafa as the building is not over 60 years old. Nevertheless, there is little architectural, historical or social significance in retaining the building.

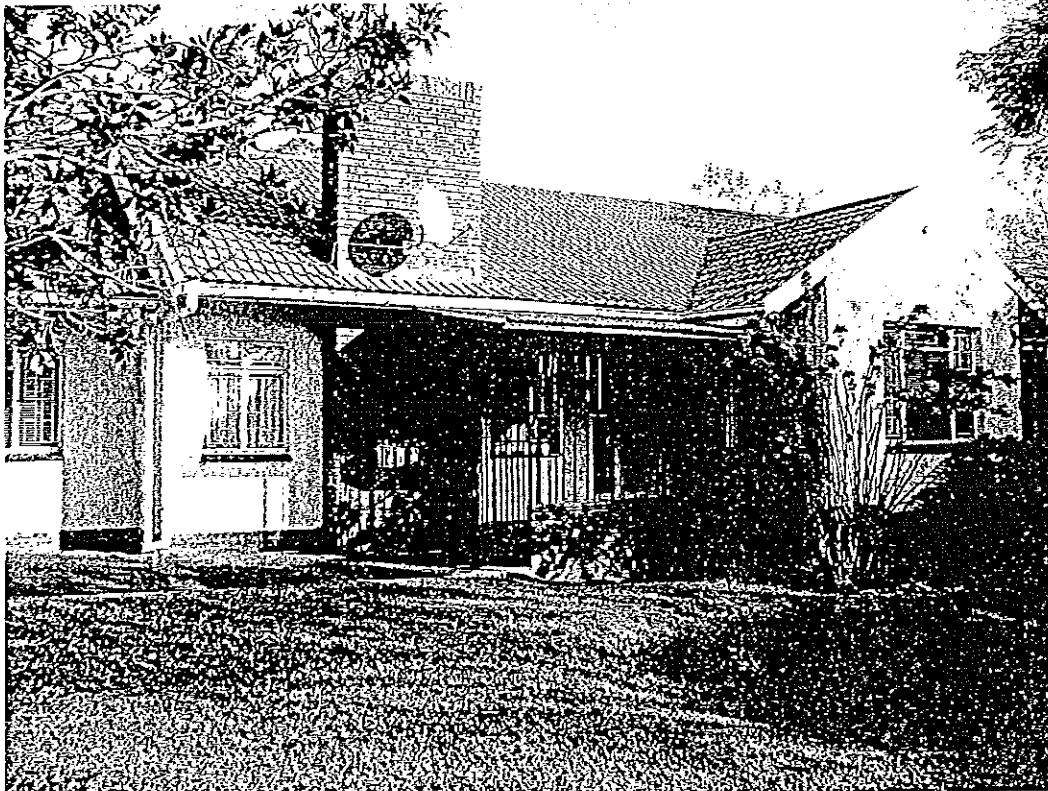
*Fig 56: House on Lot 4 of 1113*

The house is a simple orthogonal building of standard masonry construction, partly clinker brick and partly plastered and painted with steel windows under a clay tile roof. There is a prominent ranch style chimney. It is not older than 60 years, and is an example of suburban architecture of which there are scores of similar examples.

Demolition of this structure would not require a permit from Amafa as the building is not over 60 years old. Nevertheless, there is little architectural, historical or social significance in retaining the building.
